Confidential Inspection Report

5382 Roberts Ave
Lewiston, NY 14092

May 12, 2017

RADON SCREENING

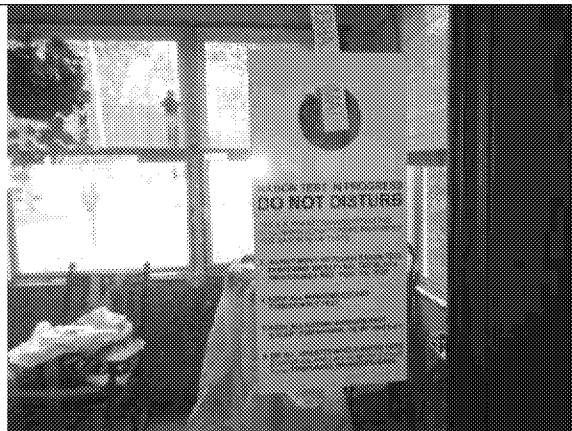
Yes, a radon test in progress sign was posted in a conspicuous area of the structure. This notice also contained a listing of the testing conditions.

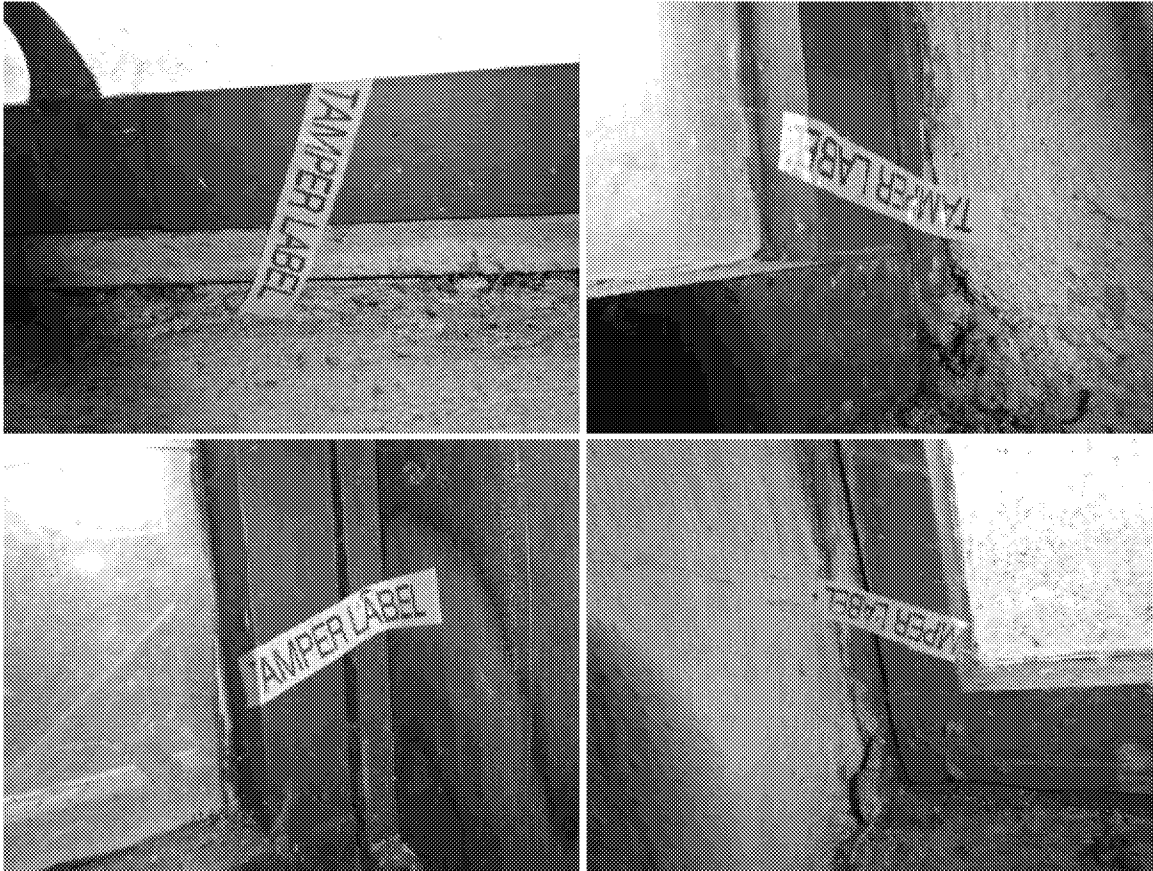
The windows and non-essential doors were sealed or tagged(BASEMENT WIDOWS ONLY)
